## Correction of Impacted Mandibular Second Molars

HOWARD J. BUCHNER, D.D.S., M.S.D.

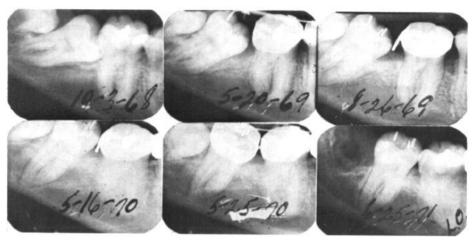
Fig. 2

The radiographs of case L.O. show the successive steps in the movement of

a severely impacted second molar (Fig. The original film was dated 1/3/68. The second one, dated 5/20/69, shows a partial correction. It is possible to see the spur in the occlusal surface of the second molar, the bracket on the first molar, the archwire, and the coil spring. The third film, dated 8/26/69, shows pins in the mesial area which were used to continue the movement. At this time the patient left for college, and a spur was soldered to the first molar band to guide the second molar in its eruption. When the patient returned on 5/16/70 the change in molar position was evident, even though it was still necessary to correct the axial position of the second molar. Bands were placed on the involved buccal segment on 5/25/70 and left in position during most of the next school year. The final radiograph, dated 6/25/71, shows the final tooth position. The impacted third molar has been extracted.
