Original Article

Bracket base remnants after orthodontic debonding

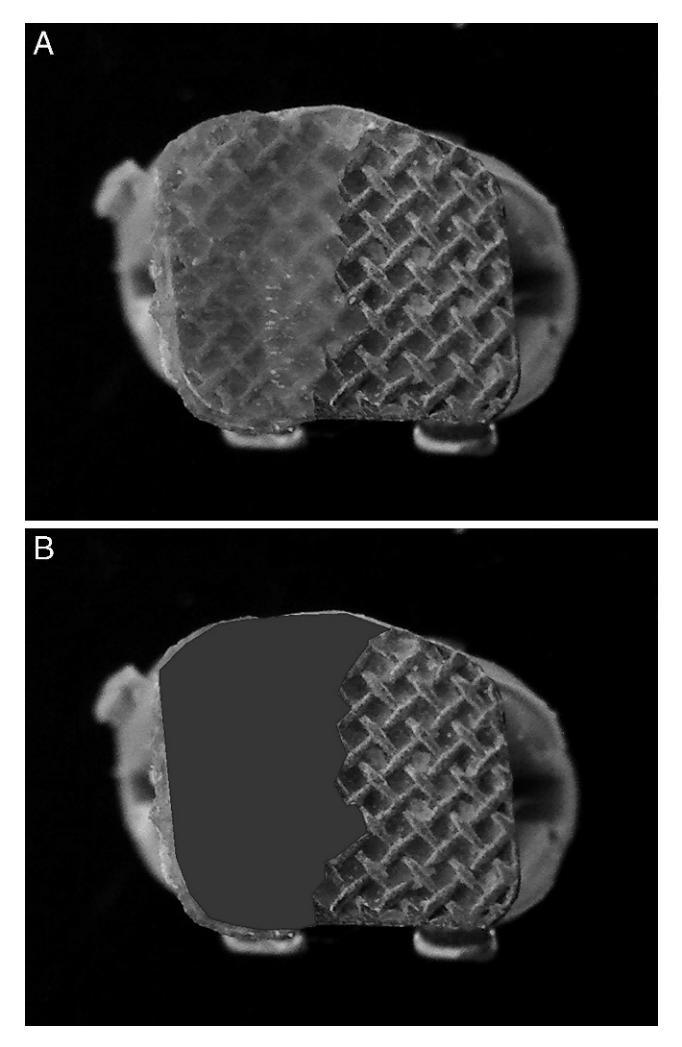
Figure 1. Representative example of the bracket-base remnant-area measurement. (A) A bracket base showing some remnants. (B) The remnant area detected with the use of Image J.

pseudo-random numbers in blocks of four digits: the first two digits individuate the patient and the last ones individuate the tooth (incisor, canine, premolar, first molar). A single expert examiner trained in micromorphologic evaluations measured the bracket base surface and the remnant surface using ImageJ opensource image-analysis software (Version 1.44o for Macintosh, National Institutes of Health, Bethesda, Md) and calculated the latter area as a percentage of the former. The outcome resulting from the pilot study was the remnant percentage. As no significant differences were found between the upper and lower arches, the two arches were unified. The mean percentage of remnants for each tooth type was used to compute the final sample size with a permissible error of 5% and a power of 95% (Table 1). Because the pilot study revealed that the sample size was statistically adequate, all 1068 brackets were observed under a digital stereomicroscope (Meade Instruments Europe, GmbH & Co KG, Rhede, Germany) at a $20 \times$ magnification. This procedure was carried out to exclude bases free of resin remnants and to select only those with some resin remnants, for scanning electron microscopy (SEM) analysis. Therefore, 818 brackets (283 incisor, 121 canine, 311 premolar, and 103 molar) were included in the study. The same examiner who analyzed the pilot-study sample measured the bracket base surface and the remnant surface using ImageJ open-source image-analysis software and calculated the latter area as a percentage of the former (Figure 1A,B).

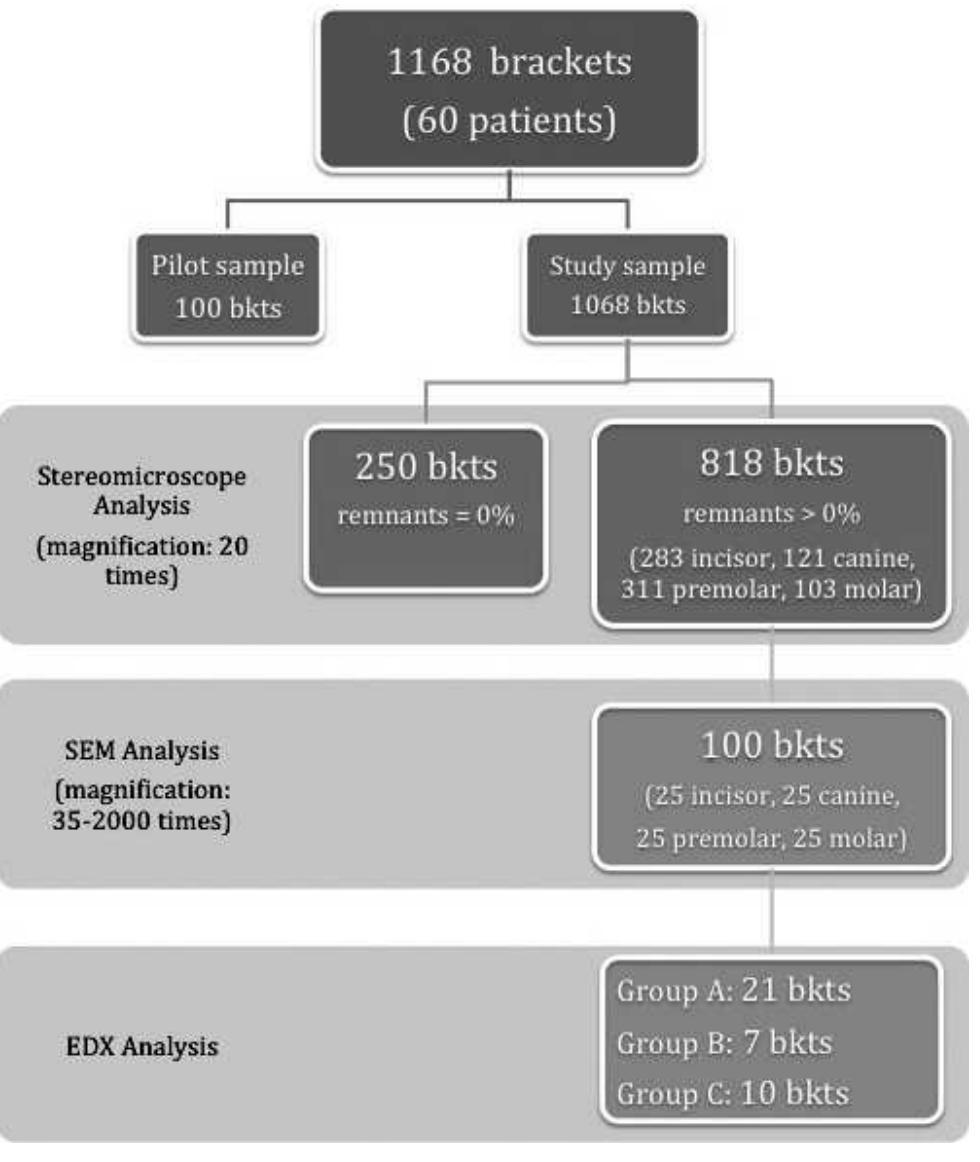
Figure 2. Graphic representation of the study design; bkts indicates brackets.

Because the SEM analysis provides only qualitative evaluation, the bracket sample was also examined through energy dispersive x-ray spectrometry (EDX) to obtain quantitative data. The EDX analysis (Stereo Scan 360, Cambridge Instrument Ltd, Cambridge, UK; using accelerating voltage, 20kV; type of detector, Si(Li)-liquid N2 cooled; detector dead time 17%; spectra acquisition time, 70 seconds; resolution, 133 eV; magnification, between 20 and $30\times$; scan mode, area) was performed on 21 brackets from group A, 7 brackets from group B, and 10 brackets from group C. The 7 bracket bases from group B were matched to 21 bracket bases from group A (ratio 1:3), which represented the clinical controls. The 10 bracket bases from group C were also analyzed. The percentage of calcium was calculated from adhesive in relation to that of silicon. Because the bonding materials used are calcium free, the presence of this element could only be attributed to enamel. The study design is summarized in Figure 2.

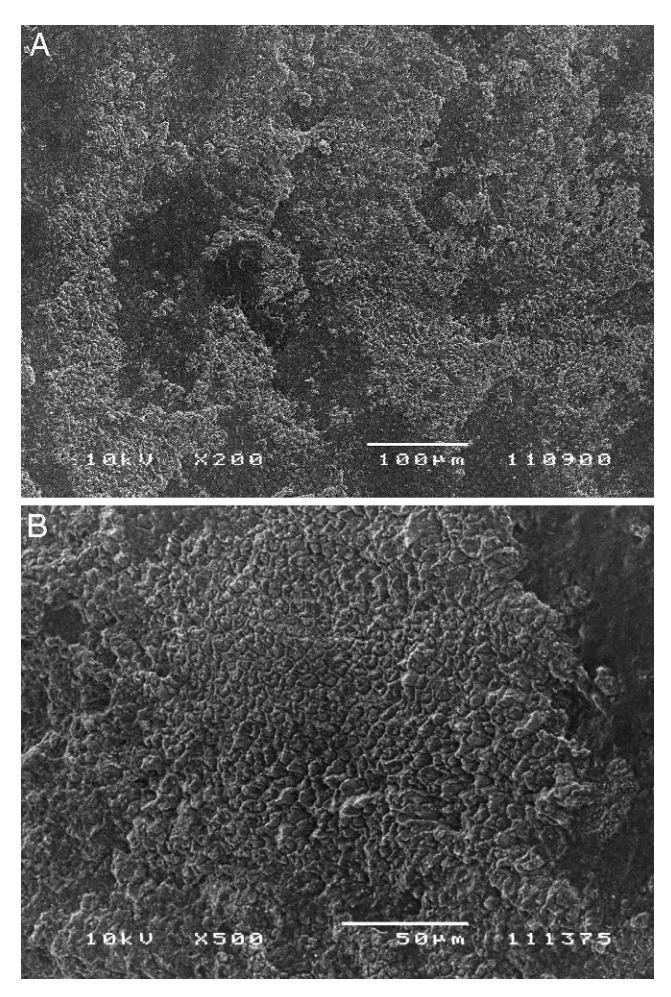
Figure 3. Representative micrograph of a bracket base showing a thin coat of enamel over the resin surface. (A) $200 \times$ magnification. (B) $500 \times$ magnification.

Figure 4. Representative micrograph of a bracket base showing enamel fragments adherent to the composite resin. (A) $200 \times$ magnification. (B) $500 \times$ magnification.

As regards the 100-bracket sample, from a morphologic analysis of the SEM micrographs, two modes of enamel presence emerged: (1) a thin coat of enamel on the resin surface was found in 83 specimens (83%) (group A) (Figure 3A,B); and (2) sizable enamel

fragments (area ranging from 306 to 1247 μ m²) on the resin were detected in 7 samples (7%) (group B) (Figure 4A,B), located on canine (n = 2), premolar (n = 3), and molar brackets (n = 2). No evidence of enamel was visible on 10 samples (10%) (group C) (Figure 5A,B), whereas EDX analysis showed the

In the present study, three morphologically different types of images were observed under the SEM: a thin enamel coat over the resin surface (83%) (Figure 3A,B), sizable enamel fragments attached to the composite resin (7%) (Figure 4A,B),⁷ or a smooth surface with no evidence of enamel presence (10%) (Figure 5A.B). It is critical to differentiate between the first and the second situation. The first finding corresponds to some enamel prism cores and interprismatic enamel that are not relevant from a clinical standpoint, whereas the second one is characterized by the typical honeycomb pattern, suggesting a fracture of sizable enamel fragments (area ranging from 306 to 1247 µm²) during debonding. In agreement with Pont et al.,8 calcium remnants were noticed on all evaluated bracket bases at the EDX analysis, even on the specimens with no morphologic evidence of enamel presence (group C) at SEM analysis; in any event, the Ca/Si ratio (5.40%) in this group was significantly lower than the Ca/Si ratio in groups A and B (16.21% and 18.77%, respectively). On the other hand, the Ca/Si ratio between group A and group B was not statistically different. This outcome indicates that through this kind of analysis it is not possible to distinguish between situations characterized by a different clinical relevance. Therefore, even though the EDX spectometry is an objective method and provides quantitative data, it should be associated with the morphologic evaluation given by the SEM to assess the damage severity.

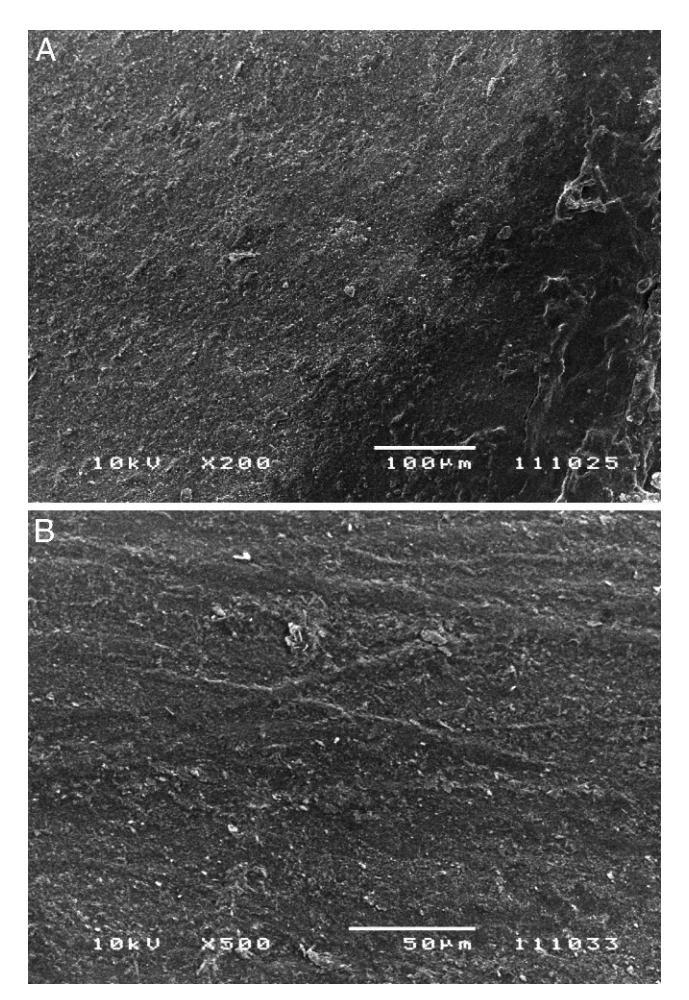
Figure 5. Representative micrograph of a bracket base showing no morphologic evidence of enamel presence. (A) $200 \times$ magnification. (B) $500 \times$ magnification.
