Original Article

Coating stability and surface characteristics of esthetic orthodontic coated archwires

Dayanne Lopes da Silva^a; Claudia Trindade Mattos^b; Renata Autoun Simão^c; Antônio Carlos de Oliveira Ruellas^d

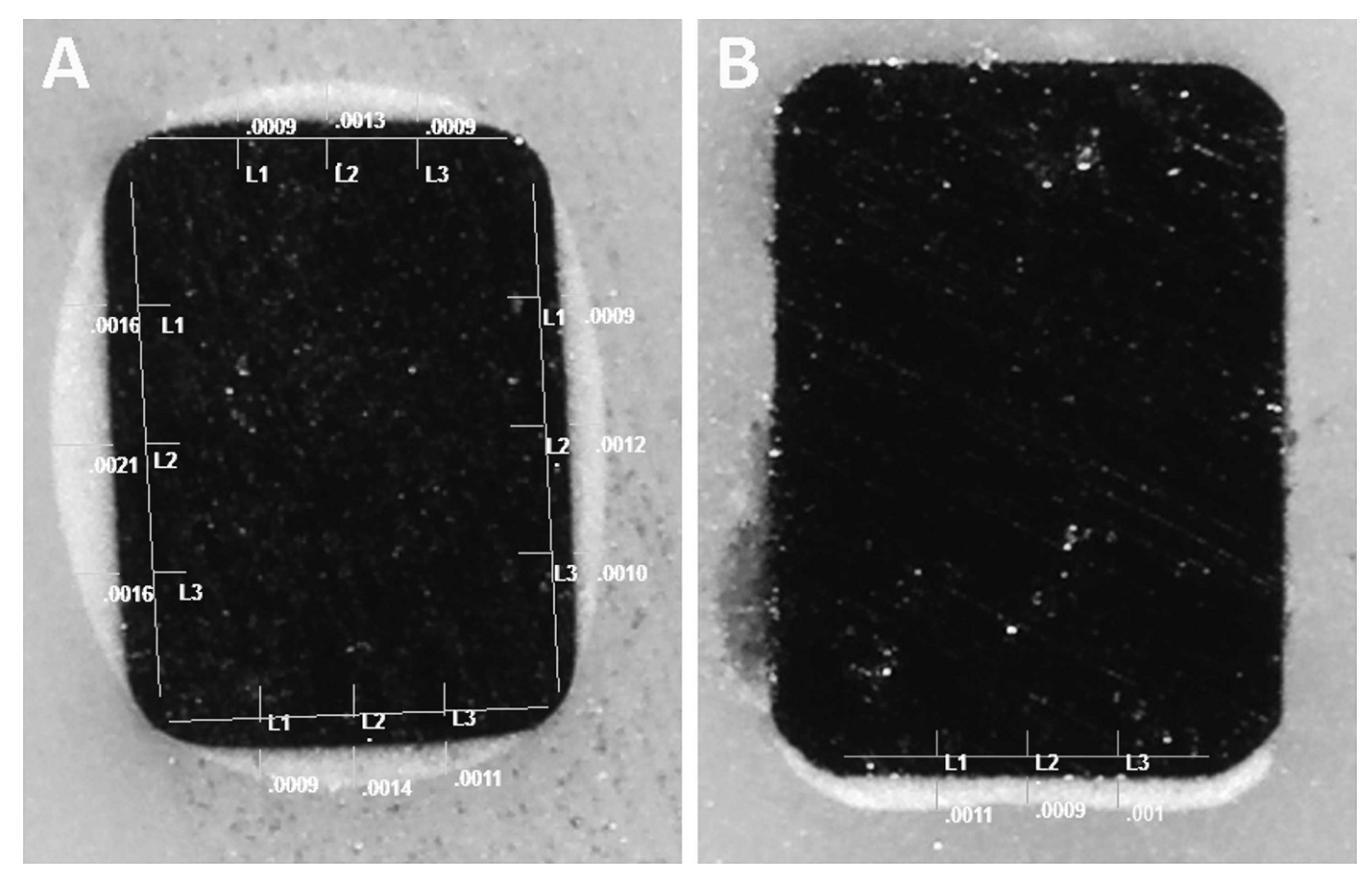
Figure 1. Stereoscope images of coating thickness measurement method: (A) group IV with all surfaces coated and (B) group II with coating only on the labial surface. Original magnification 45×.

Images of transverse sections from the specimens were made with a stereoscope at $45 \times$ magnification (Olympus SZ61; Olympus, Tokyo, Japan). The coating thickness of all coated surfaces of each wire was measured using Image Pro Plus 4.5 software (Media Cybernetics, Silver Spring, Md). For each coated surface, three coating thickness readings were measured randomly (Figure 1). The operator was previously calibrated (intraclass correlation coefficient = .99) by measuring 10 samples twice.

Coating thickness for as-received wires is shown in Table 2. All groups showed an average coating thickness of less than 0.002 inches, which is the thickness informed by the manufacturers. Group IV had the highest average coating thickness, but it was the most irregular one, assuming a round crosssectional aspect (Table 2 and Figure 1A). The most uniform coating was present in group II (Figure 1B). A lower coating thickness was observed on the corners in all groups.

Additionally, as-received coated wires did not show a uniform coating-thickness pattern (Table 2). The coating layer clearly tended to be thicker in the center and thinner on the edges of labial surface (or all surfaces; Figure 1). This characteristic could make the coating layer more susceptible to damage. Besides, this irregularity in coating thickness might impair the wirebracket slot engagement, influencing tooth movement.

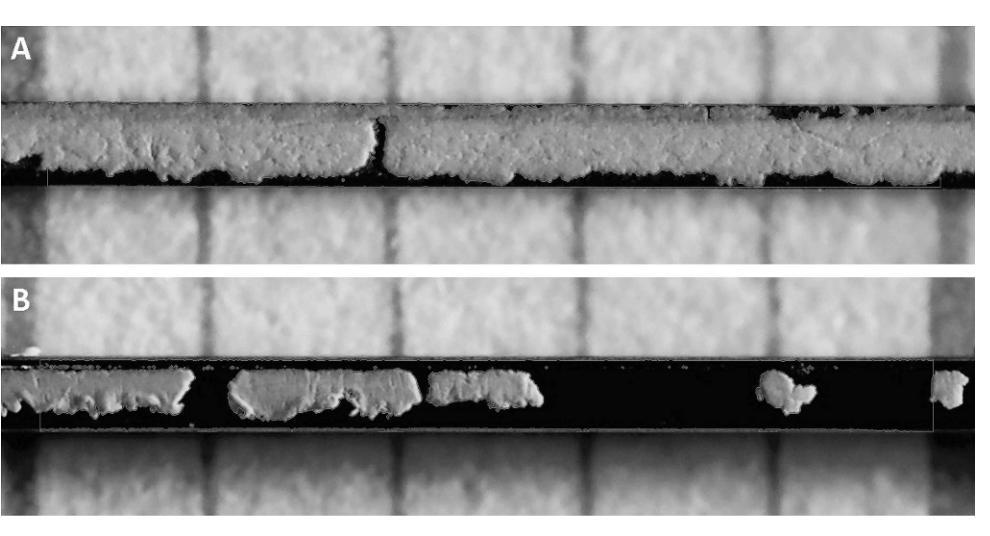
Figure 2. Representative stereoscope images of labial surfaces of postclinical coated wires, where lost coating was measured using Image Pro Plus 4.5 software: (A) group II and (B) group IV. Original magnification 35×.

An Olympus SZ61 stereoscope was used to study the labial surface topography of the wires at $35 \times$ magnification, and digital images were recorded. The lost coating on the labial surface of all retrieved coated wires was measured using Image Pro Plus 4.5 software. Graph paper with a width of 10 mm was fixed on a glass

slide and served as a template. Each wire was positioned with the midpoint on the center of the graph paper, and the ends were fixed with wax. Two 5-mmlong images were obtained of the same sample, one on its right side and one on its left side. Thus, the 10-mm segment of each coated wire located in the interbracket space was fully evaluated (Figure 2).

exposing the metallic surface below completely. On average, 28.71% and 72.90% of coating was lost in groups II and IV, respectively (Figure 2).

The coating layer peeled off in many areas during oral exposure, leaving surface defects. This peeling characteristically started by the upper and lower labial edges—because these are tensile accumulation zones with lower coating thickness—and toward the center of the surface (Figure 2). This clearly affects the esthetic value of these coated wires. These results agree with a study by Elayyan et al.⁷ in which the coating was partially lost, with increased roughness after clinical use. However, this study just evaluated one type of esthetic archwire and did not compare its surface

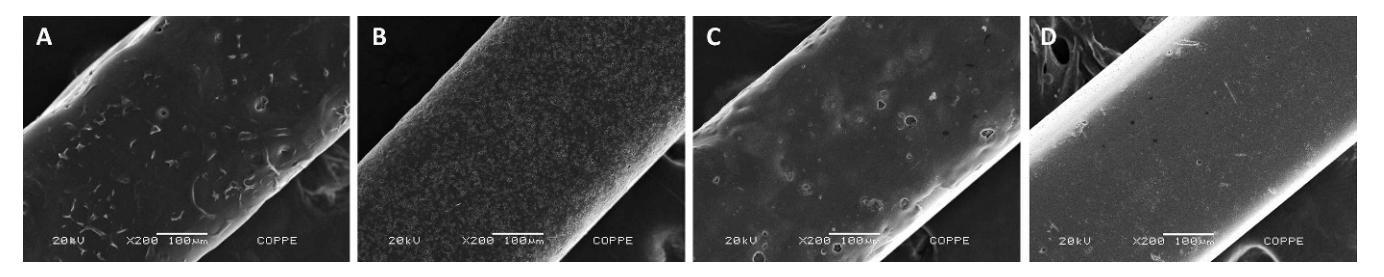
Figure 3. Photomicrographs of as-received coated wires: (A) group I, (B) group II, (C) group III, and (D) group IV. Original magnification 200×.

Figure 3 shows the evaluation of the labial surface topography of the as-received coated wires with SEM photomicrographs. Many of the specimens were characterized by small delamination and irregularities of the coating over some points. Group IV presented the smoothest surface aspect and group II the roughest.

The labial surface topography of as-received coated wires with SEM showed coating delamination and irregularities (Figure 3). A great variation in the type

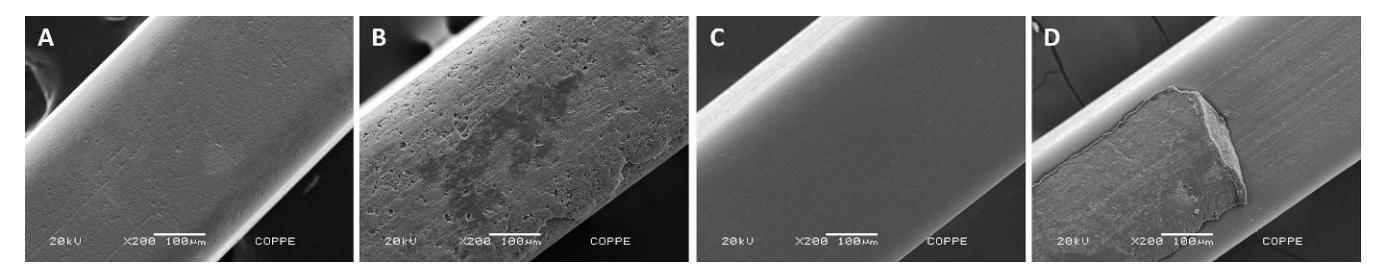
Figure 4. Photomicrographs of postclinical coated wires: (A) group I with the entire coating layer lost, (B) group II with remaining coating, (C) group III with the entire coating layer lost, and (D) group IV with remaining coating. Original magnification 200×.

Illustrative SEM photomicrographs of retrieved coated wires are shown in Figure 4. The entire coating layer on the labial surface was lost in groups I and III, exposing the metallic surface underneath. Group IV showed some areas of coating delamination, but the metallic surface underneath presented an appearance similar to the retrieved control wires, as in groups I and III. Coating delamination areas on retrieved wires of group II showed a rougher metallic surface aspect than retrieved control wires (Figure 5).

The surface quality of the products investigated differs significantly. A dominant factor in the determination of the surface structure of an orthodontic archwire is the production technique. As the production techniques are generally similar for all types of wires from one manufacturer, the differences in the surface roughness of peeled areas of coated wires is probably due to the method of applying the coating, which could require some surface treatment and/or heat treatment, or due to the properties and composition of the coating material. No group had its entire coating layer maintained and at the same time presented a surface roughness similar to the ones from the control wires after oral exposure. The surface roughness of the remaining coating in groups II and IV, which maintained the coating layer partially, was higher than postclinical control wires and showed a highly deteriorated surface (Table 4 and Figure 4).

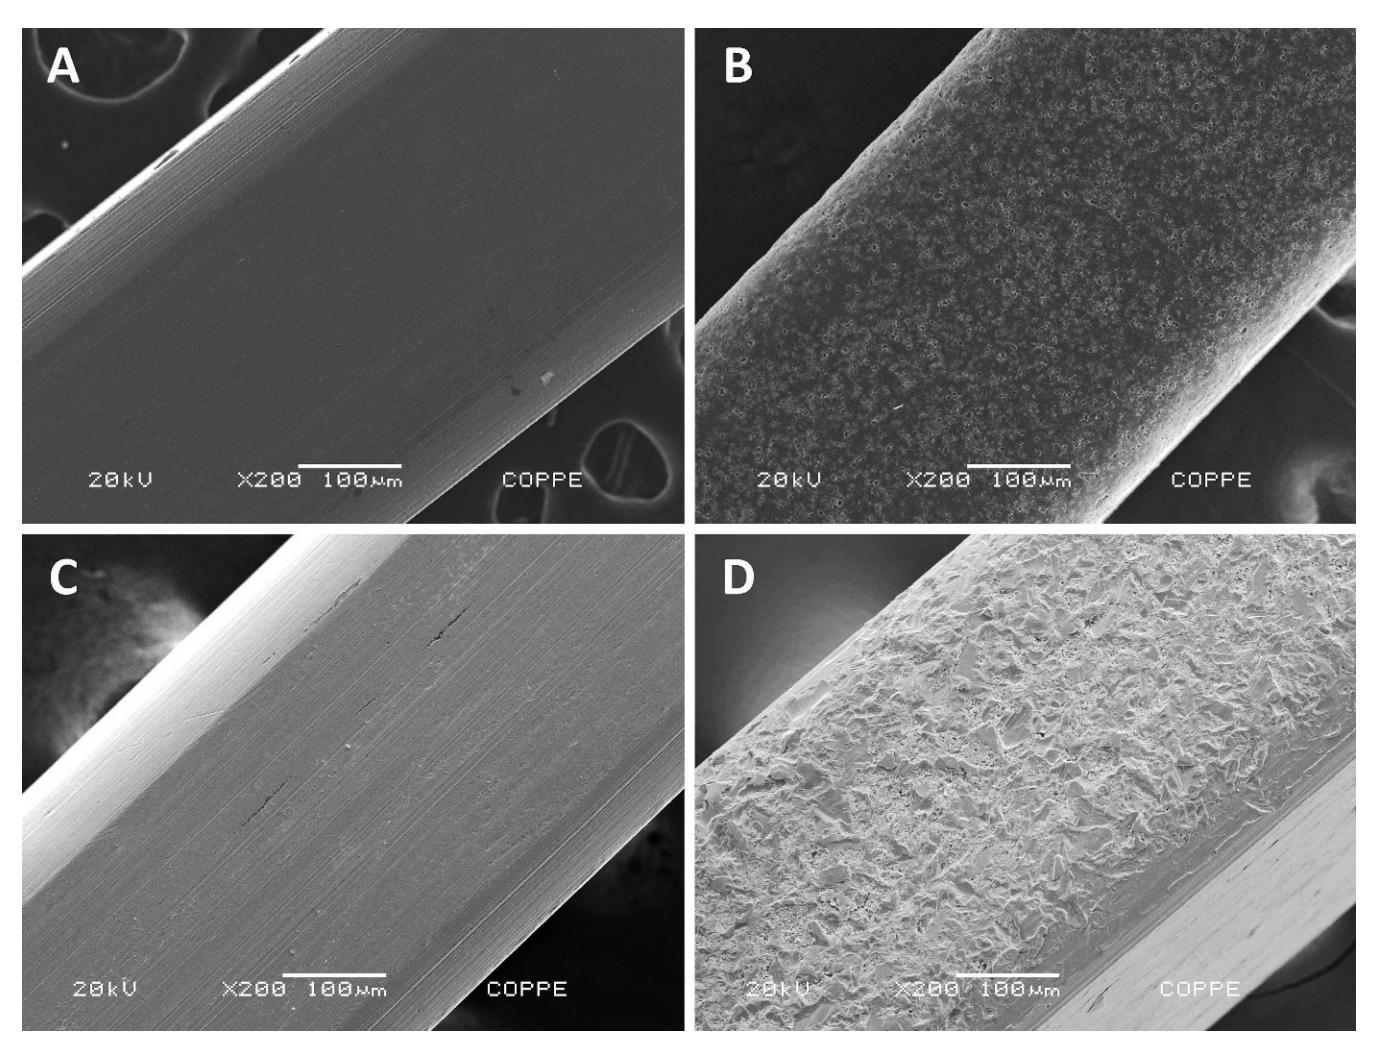
Figure 5. Photomicrographs of group II wires: (A) as-received control wire, (B) as-received coated wire, (C) postclinical control wire, and (D) rough surface of postclinical coated wire that lost the coating layer. Original magnification $200 \times$.

The smaller loss of the coating layer in group II may be due to a surface treatment on stainless steel, which makes the labial surface where the coating is applied rougher, improving the mechanical adhesion between the coating and substrate (Figure 5). Peeled areas on these wires that exposed the metallic surface underneath presented a higher surface roughness than that of postclinical control wires (Table 4). Moreover, the surface roughness of the remaining coating was also higher than that of postclinical control wires. The irregular surfaces observed microscopically, some areas of the remaining coating layer and some areas of metallic exposure, may lead to plaque accumulation in surface defects, and tooth movement may be affected due to entrapment of bracket edges inside these defects, according to some authors.^{8,9,18}
