Original Article

Comparison of shear bond strength of brackets recycled using micro sandblasting and industrial methods

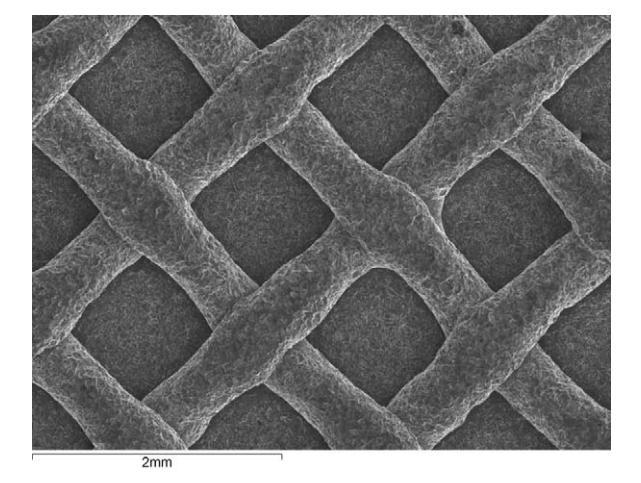
Figure 1. Scanning electron micrograph of bracket base of a new bracket (control group). Original magnification $100 \times$.

Bracket base examination under SEM revealed that the control bracket had a smooth base with a multistranded wire structure and clean retentive areas in between the wires (Figure 1). After reconditioning, brackets showed higher loss of definition in retentive areas as aluminum oxide particle size increased, due
